**Hydrogeological Report for Proposed
Wellings of Brockville Residential
Subdivision, Brockville, ON**

FINAL REPORT

November 29, 2023

Project Number:
160401602

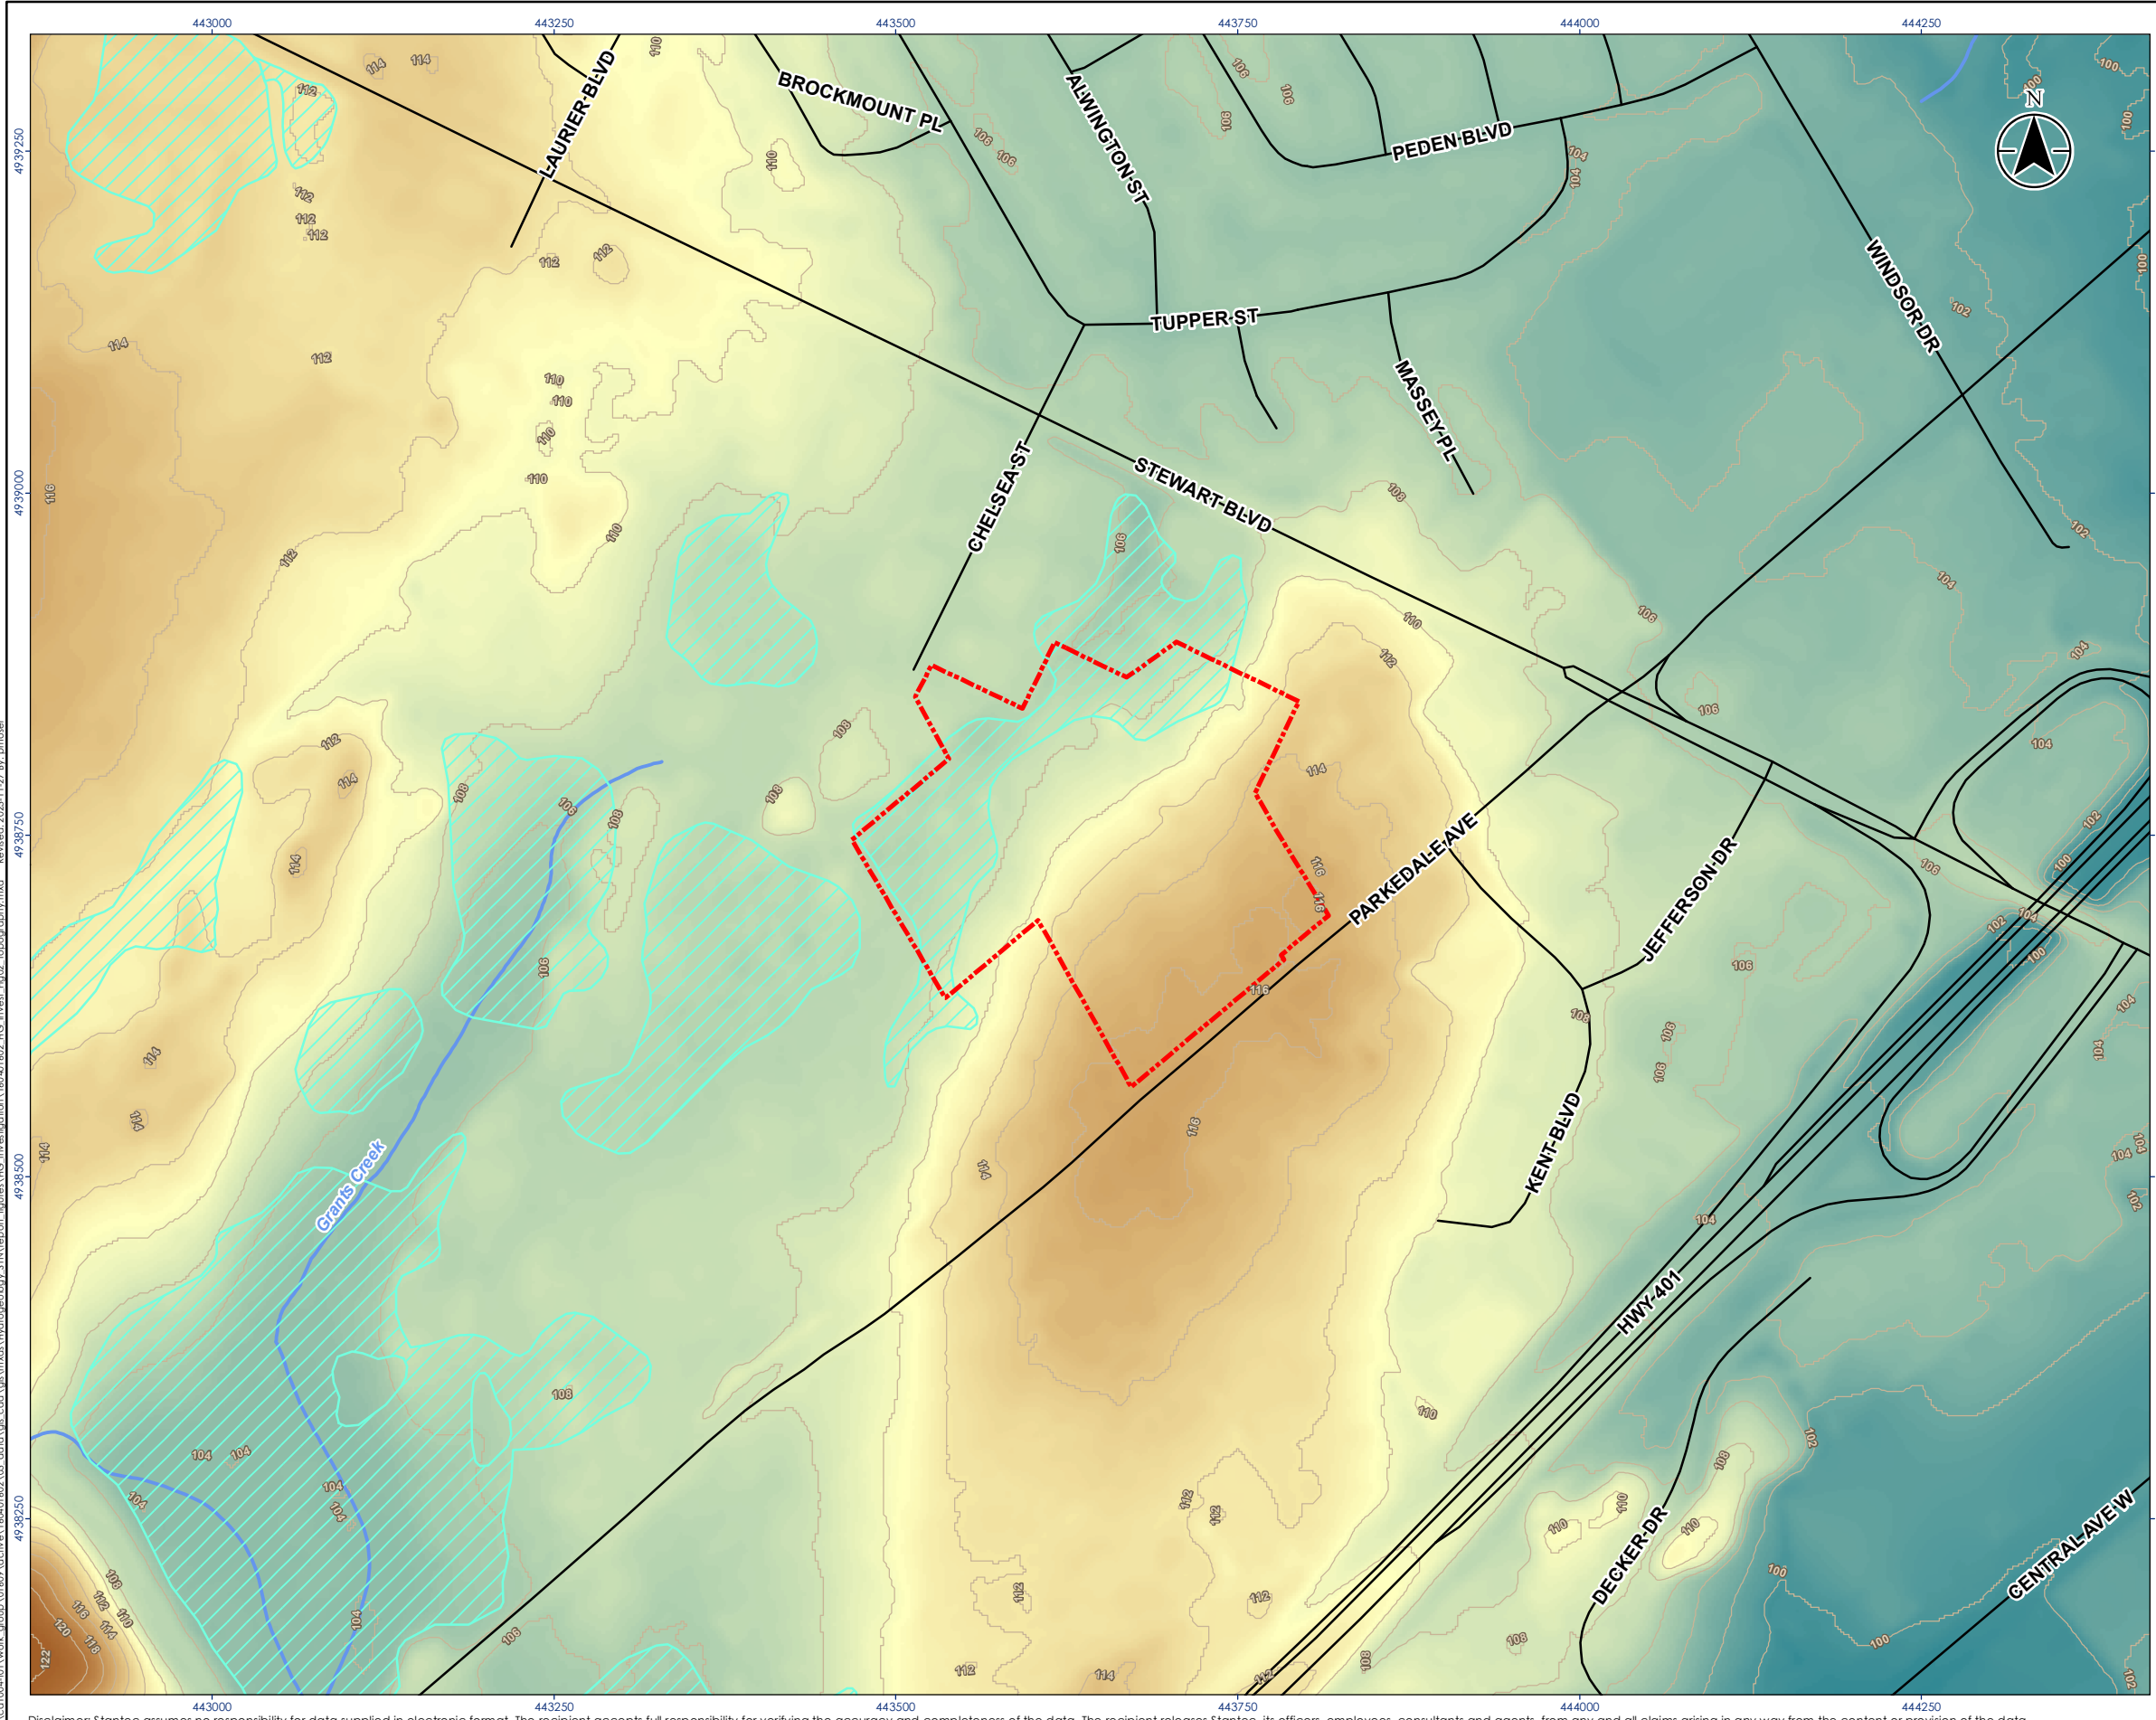
Figure No. **2**
 Title: **Topography and Drainage**

As shown on **Figure 2**, overland drainage flows in a northerly direction, towards the unevaluated wetland areas associated with Grants Creek. Grants Creek reflects an intermittent watercourse on the north side of the Site. Perennial flow within Grants Creek is generally observed on the east side of the Brockville Landfill, approximately 700 m west of the Site. Grants Creek flows in a westerly direction, outflowing into Lake Ontario on the west side of the City.

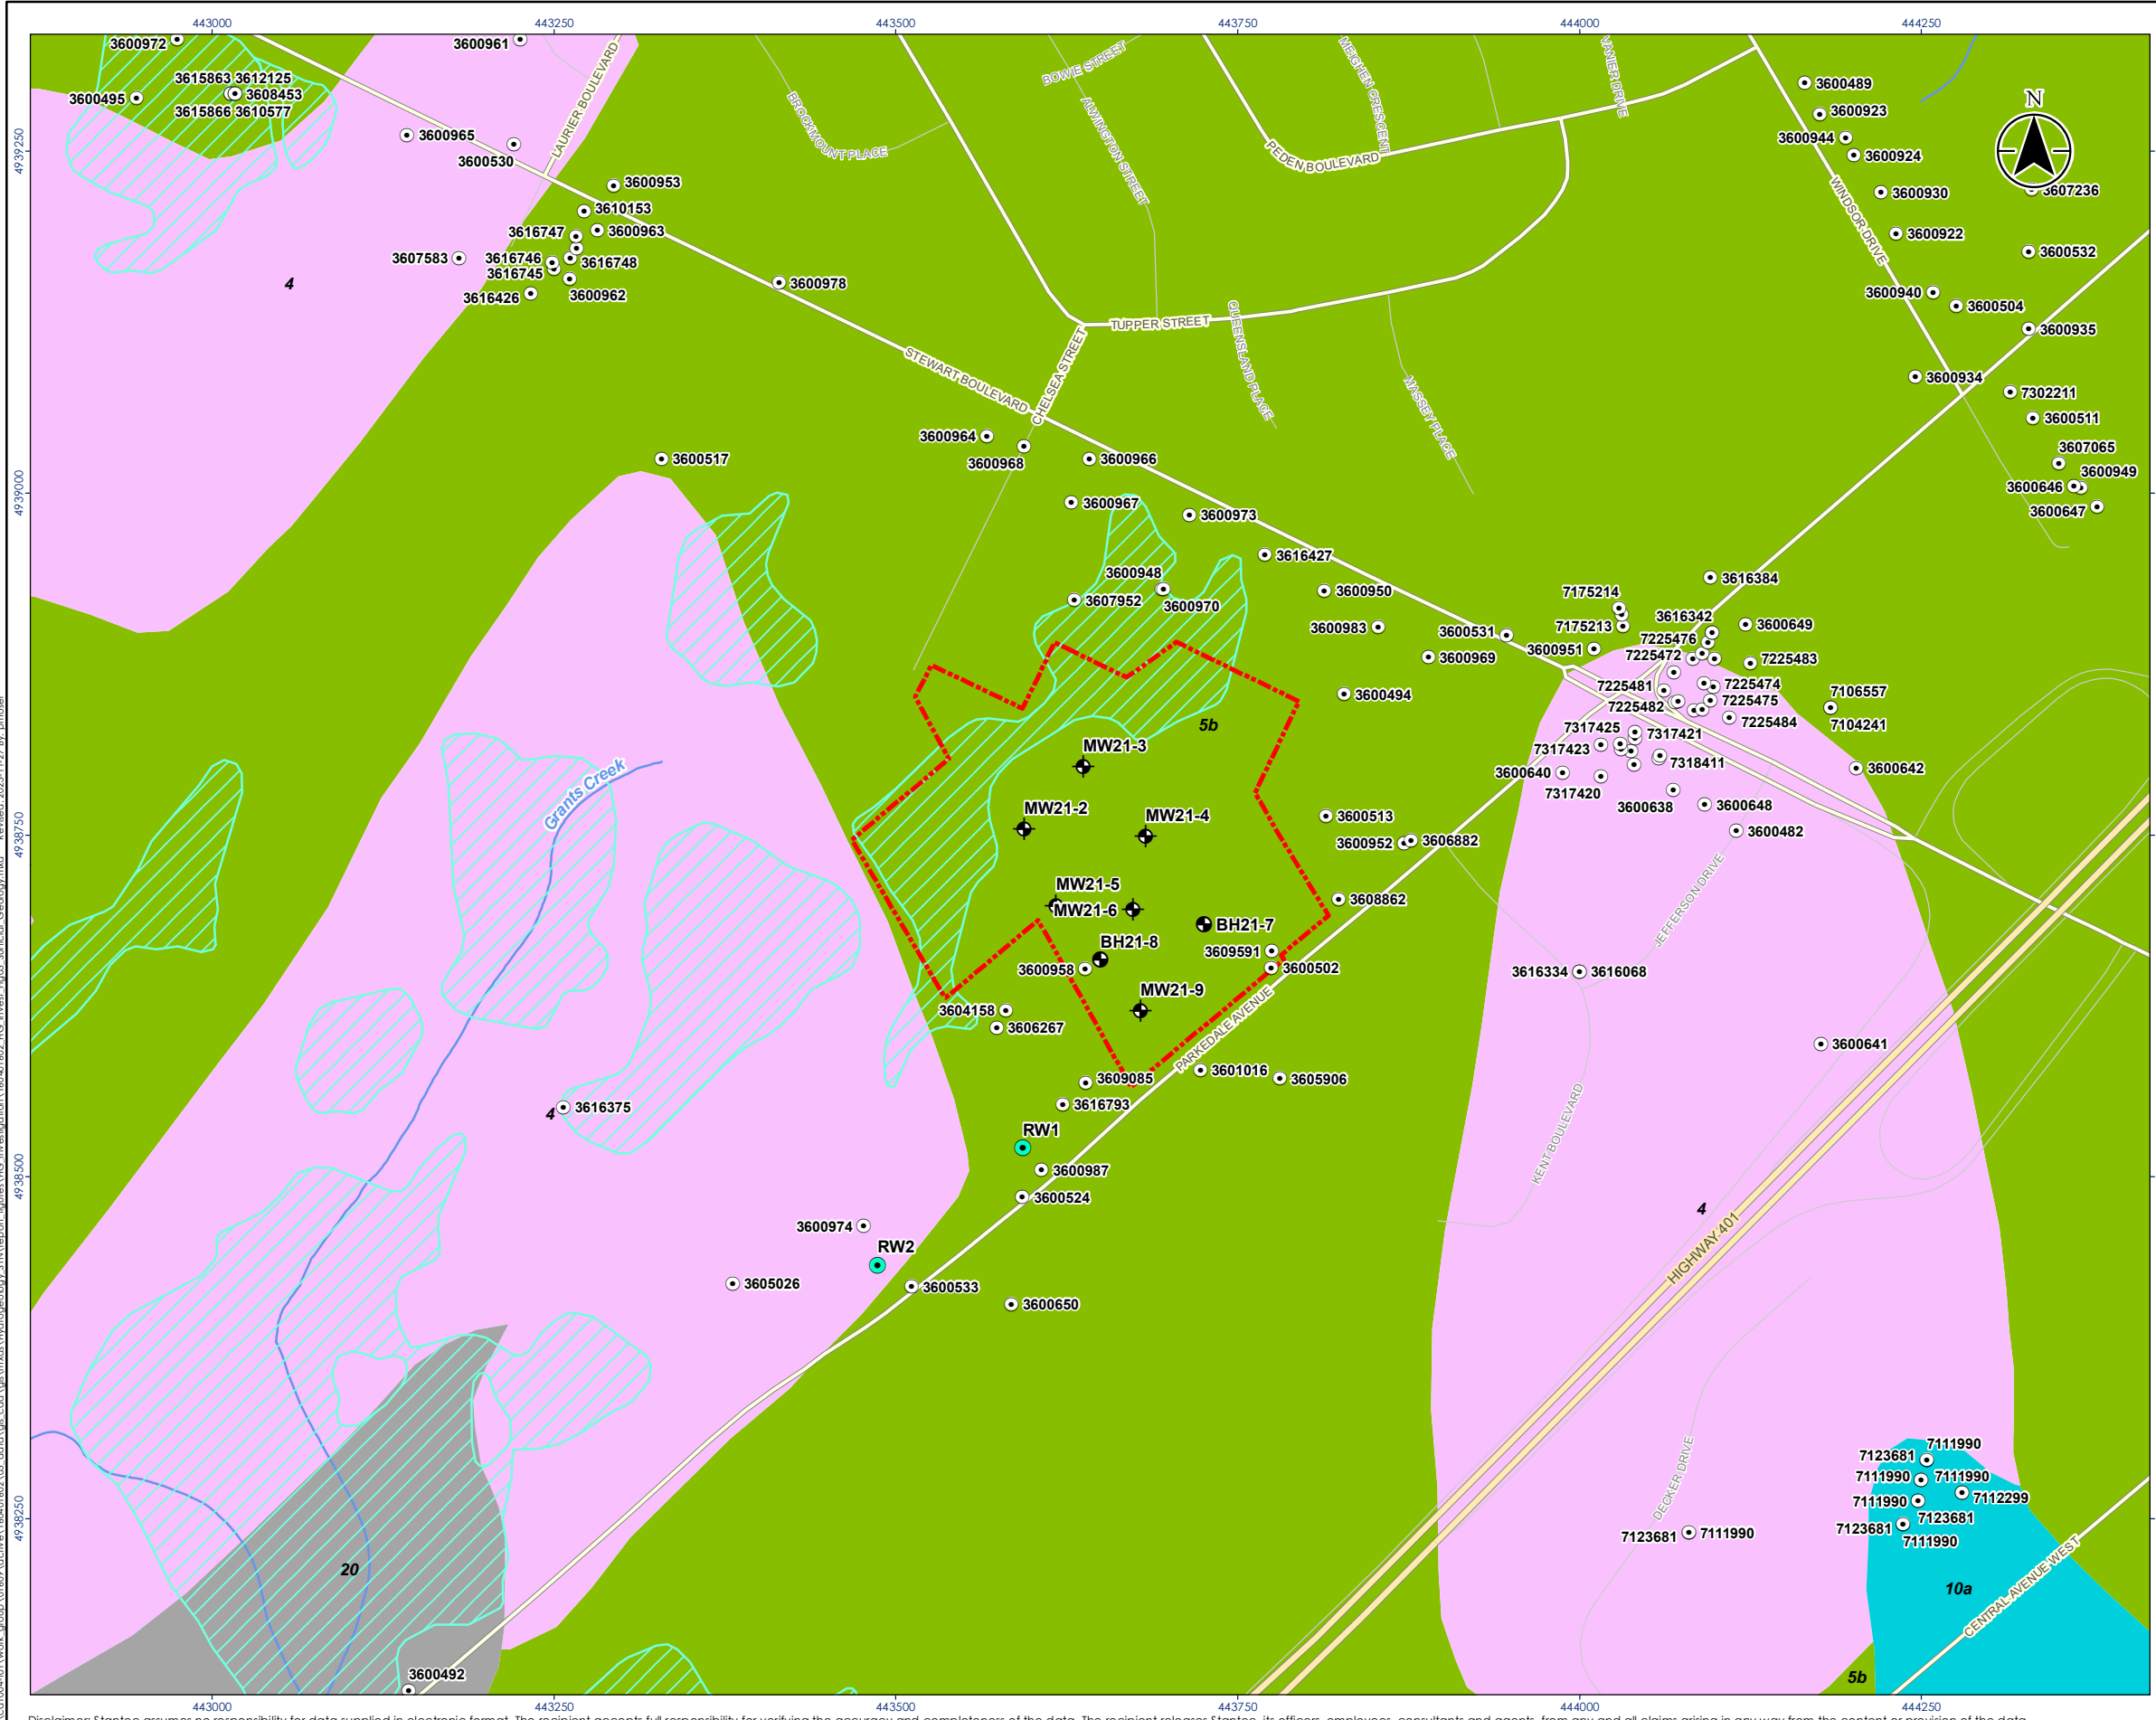
Figure No.: **3**
Title: **Surficial Geology**

- Legend**
- Property Boundary
 - + Geotechnical Borehole and Monitoring Well (Stantec, 2021)
 - Geotechnical Borehole (Stantec, 2021)
 - Surveyed Domestic Well
 - Water Well Location
 - Expressway / Highway
 - Major Road
 - Minor Road
 - Watercourse
 - Wetland - Not evaluated per Ontario Wetland Evaluation System
- Surficial Geology**
- 20: Organic deposits
 - 10a: Fine-textured glaciomarine deposits (Massive-well laminated)
 - 5b: Stone-poor, carbonate-derived silty to sandy till
 - 4: Paleozoic bedrock-drift complex

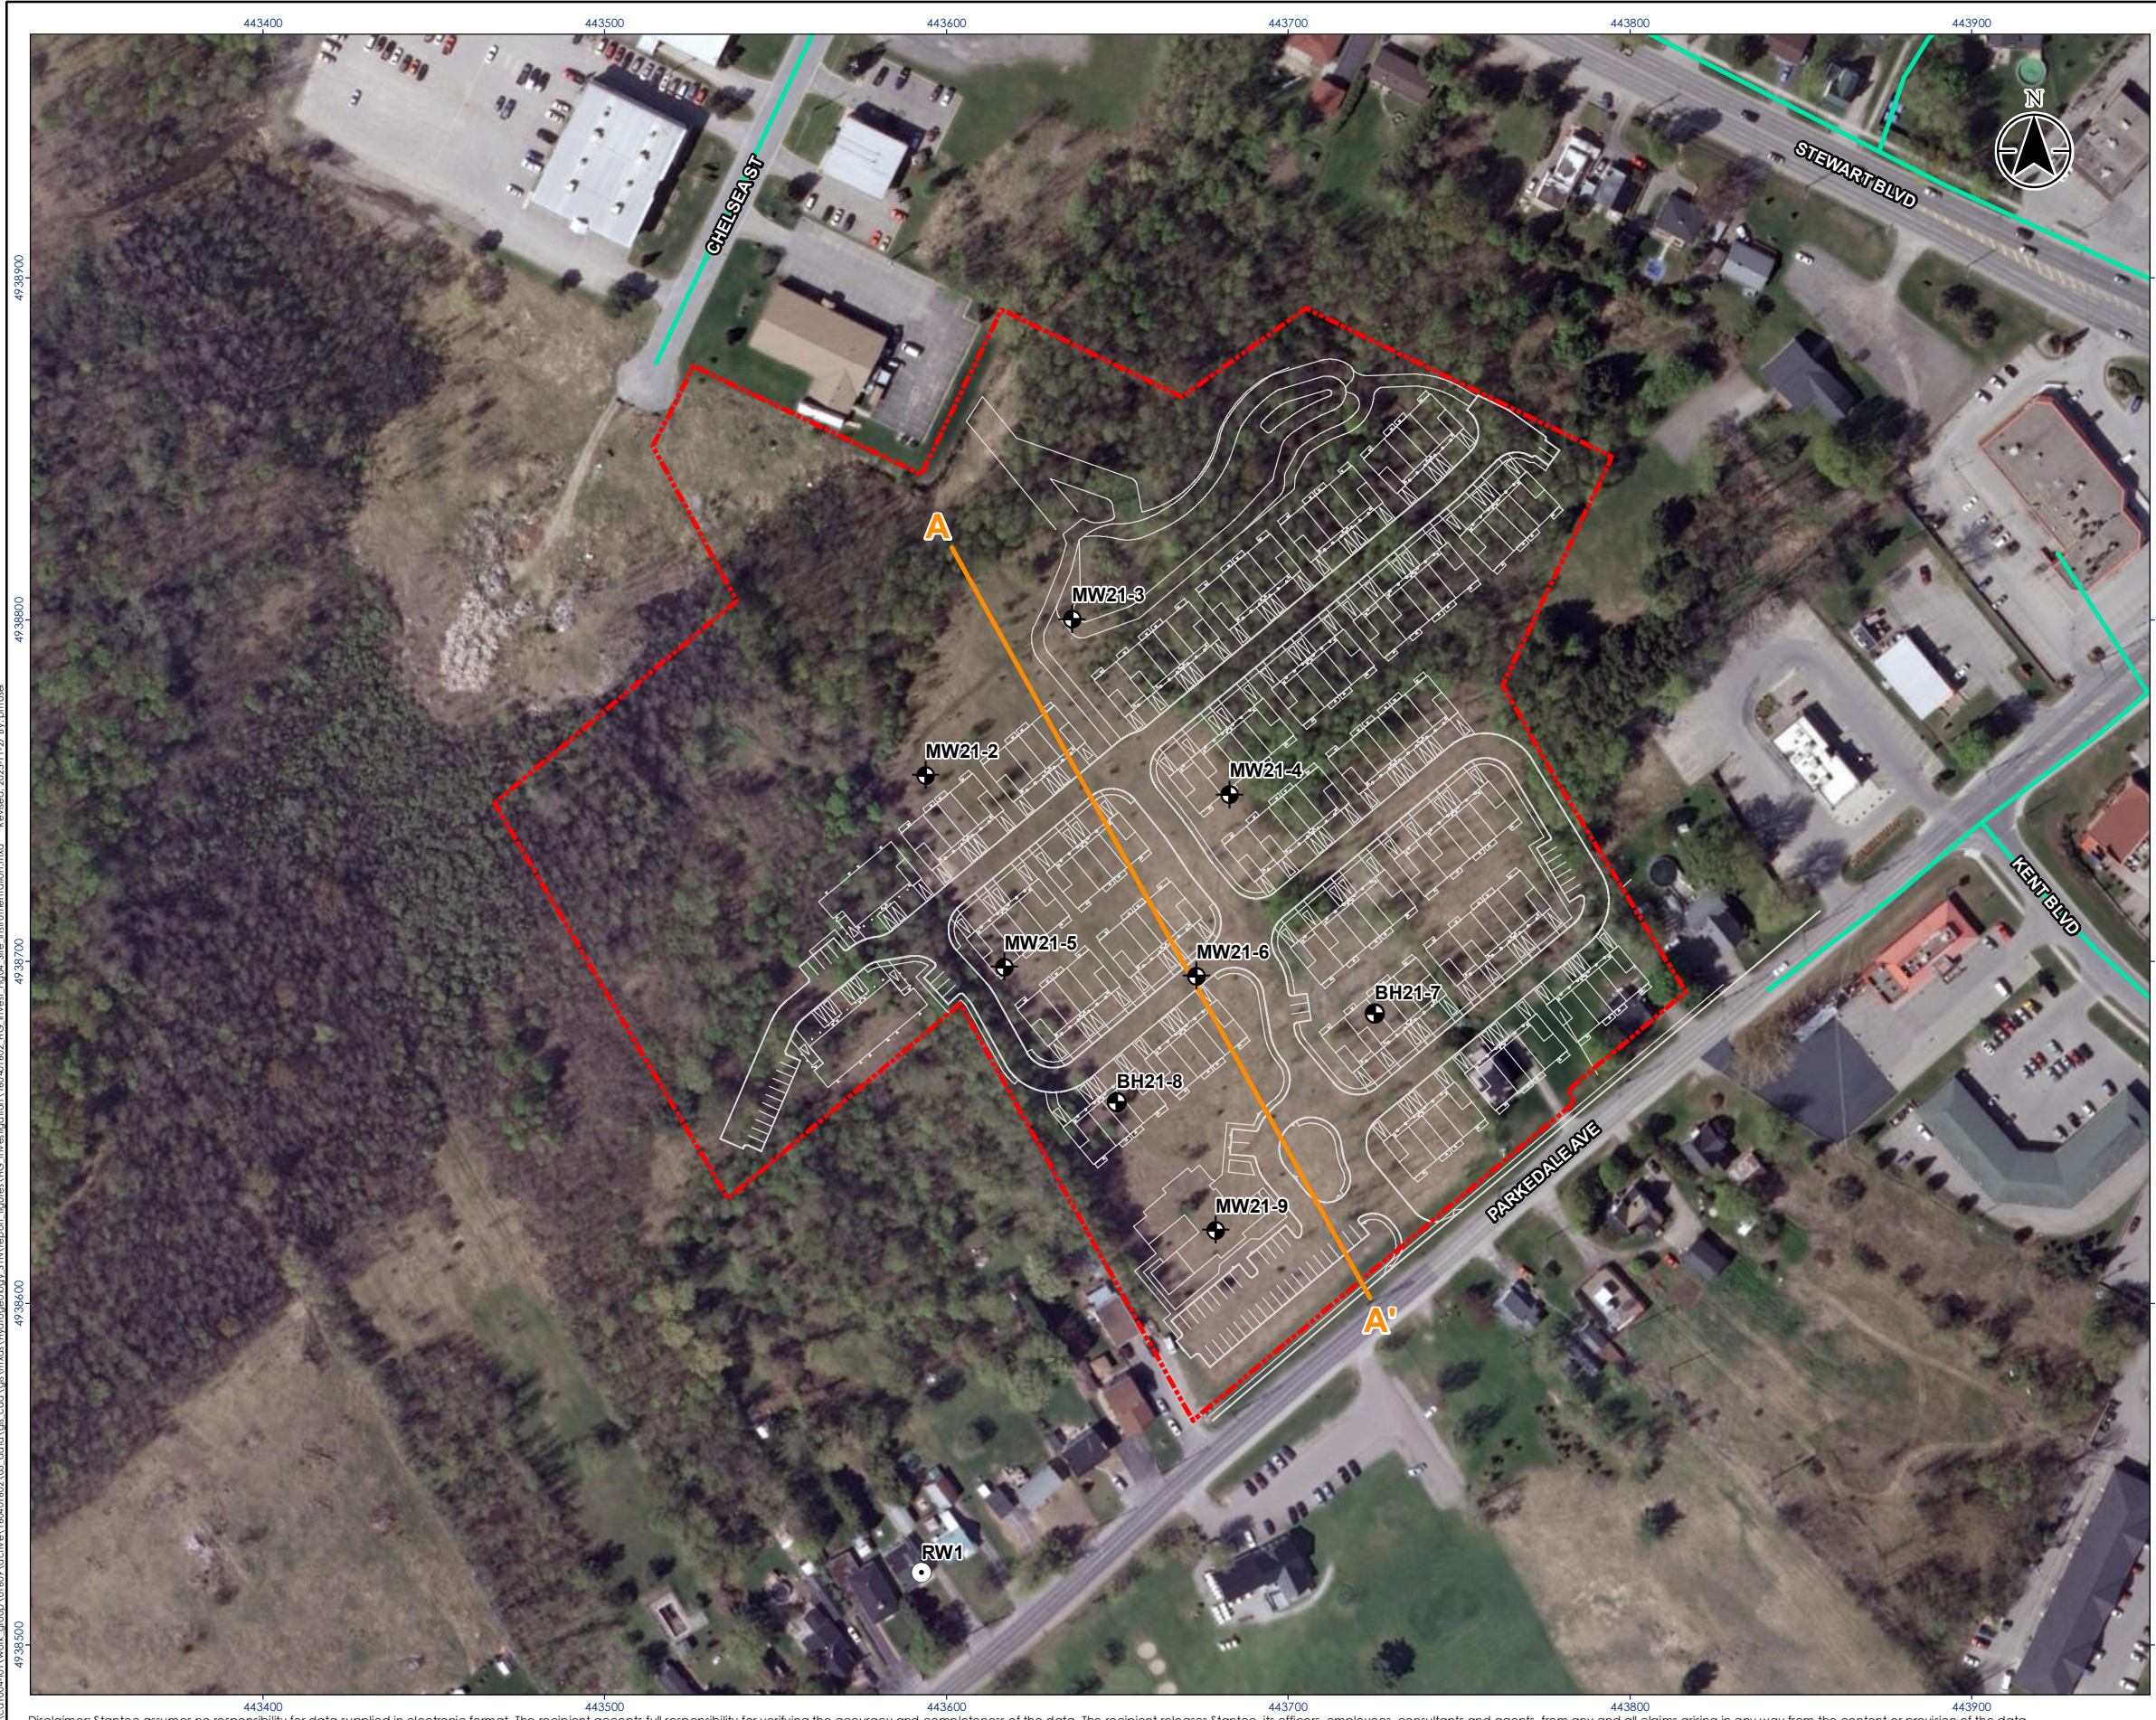
Figure No.
4

- Legend**
- Property Boundary
 - Geotechnical Borehole and Monitoring Well (Stantec, 2021)
 - Geotechnical Borehole (Stantec, 2021)
 - Surveyed Domestic Well
 - Proposed Site Layout
 - Cross-Section Location
 - Municipal Watermain

On-Site geotechnical borehole logs are shown in profile (Cross-Section A-A') on **Figure 6**. The location of the profile, relative to the Site, is shown on **Figure 4**. Borehole drilling results indicate soil conditions consistent with the description provided in Section 2.3 above. Soil conditions beneath the Site, reflecting the following layers from ground surface down:

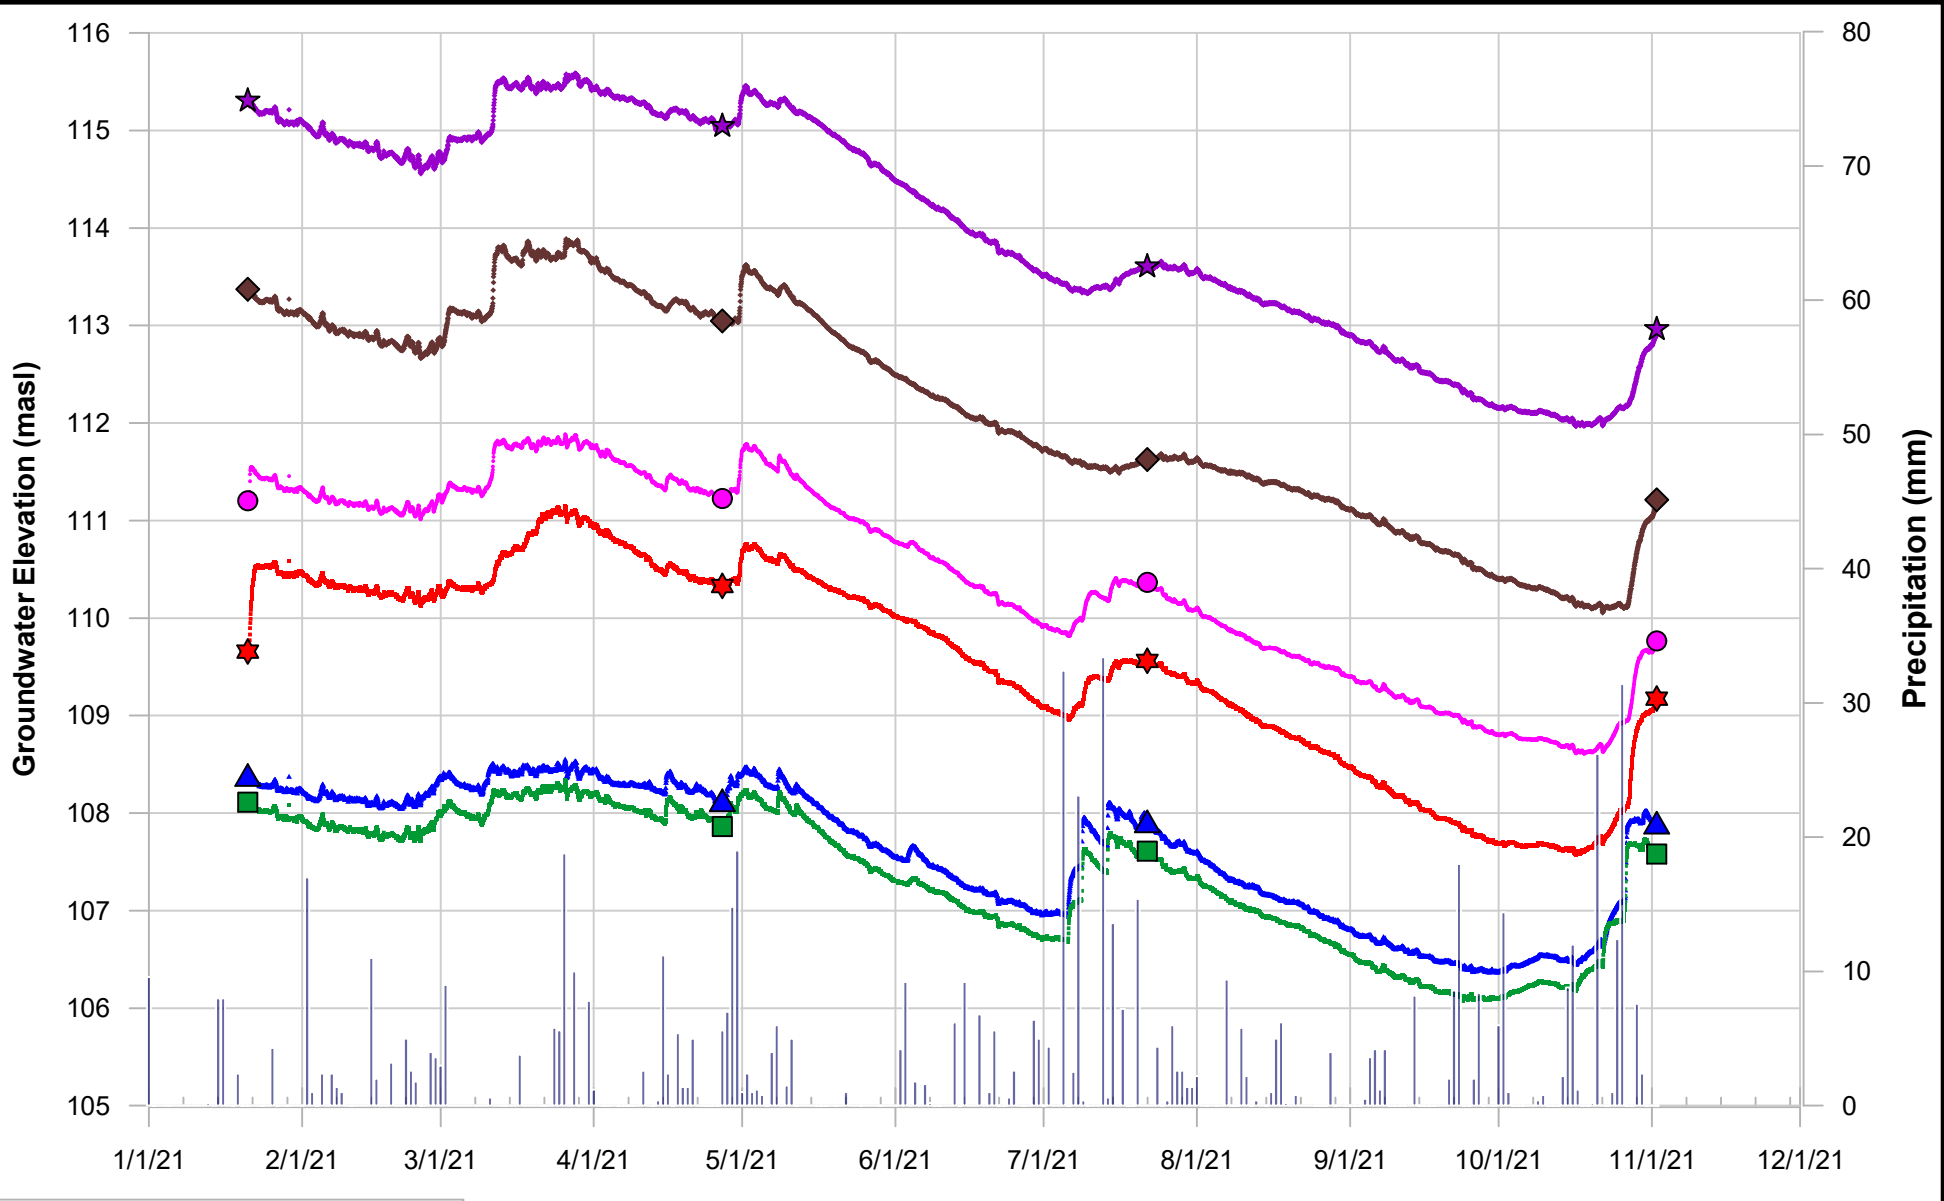
Monitoring Well Hydrographs		
DRAWN: AW	APPROVED: SMD	DATE: March 2022
PROJECT NUMBER: 160401602		FIGURE: 5

Continuous and manual water level data measured within onsite monitoring wells from January 21, 2021 through November 5, 2021 are summarized on **Figure 5** and **Table 2**, respectively. Observed groundwater levels within these monitoring wells generally ranged from 116 to 107 masl. These groundwater levels are interpreted to reflect a local water table elevation (i.e., a shallow groundwater flow system).

Hydrograph patterns shown on **Figure 5** are similar, indicating a consistency of water table fluctuations across the Site. The highest groundwater elevations (i.e., as observed manually on January 21, 2021) are summarized on **Figure 7**, which shows the seasonal high water table elevation and groundwater flow patterns across the Site. The water table is a subdued reflection of the surface topography. In general, groundwater flows in a northerly direction across the Site, towards the Grants Creek valleyland.

A cyclical pattern of groundwater fluctuations is common within shallow groundwater systems in southern Ontario. High water table conditions occur in the winter and spring (i.e., January to May) due to lower evapotranspiration losses and a melting snowpack, which provide a greater volume of water for recharge. These general observations are evident within the hydrographs, which show a dramatic response to groundwater recharge events in December 2020 and March 2021. Low water table conditions generally occur in the late summer to early fall as more water is drawn from the subsurface over this period to meet evapotranspiration demands. These patterns are also observed in the hydrographs which are lowest during the summer season. The total range of water table fluctuation observed between the spring and summer of 2021 ranges from 2 m in the lower elevation of the Site to 3 m in the upland area.

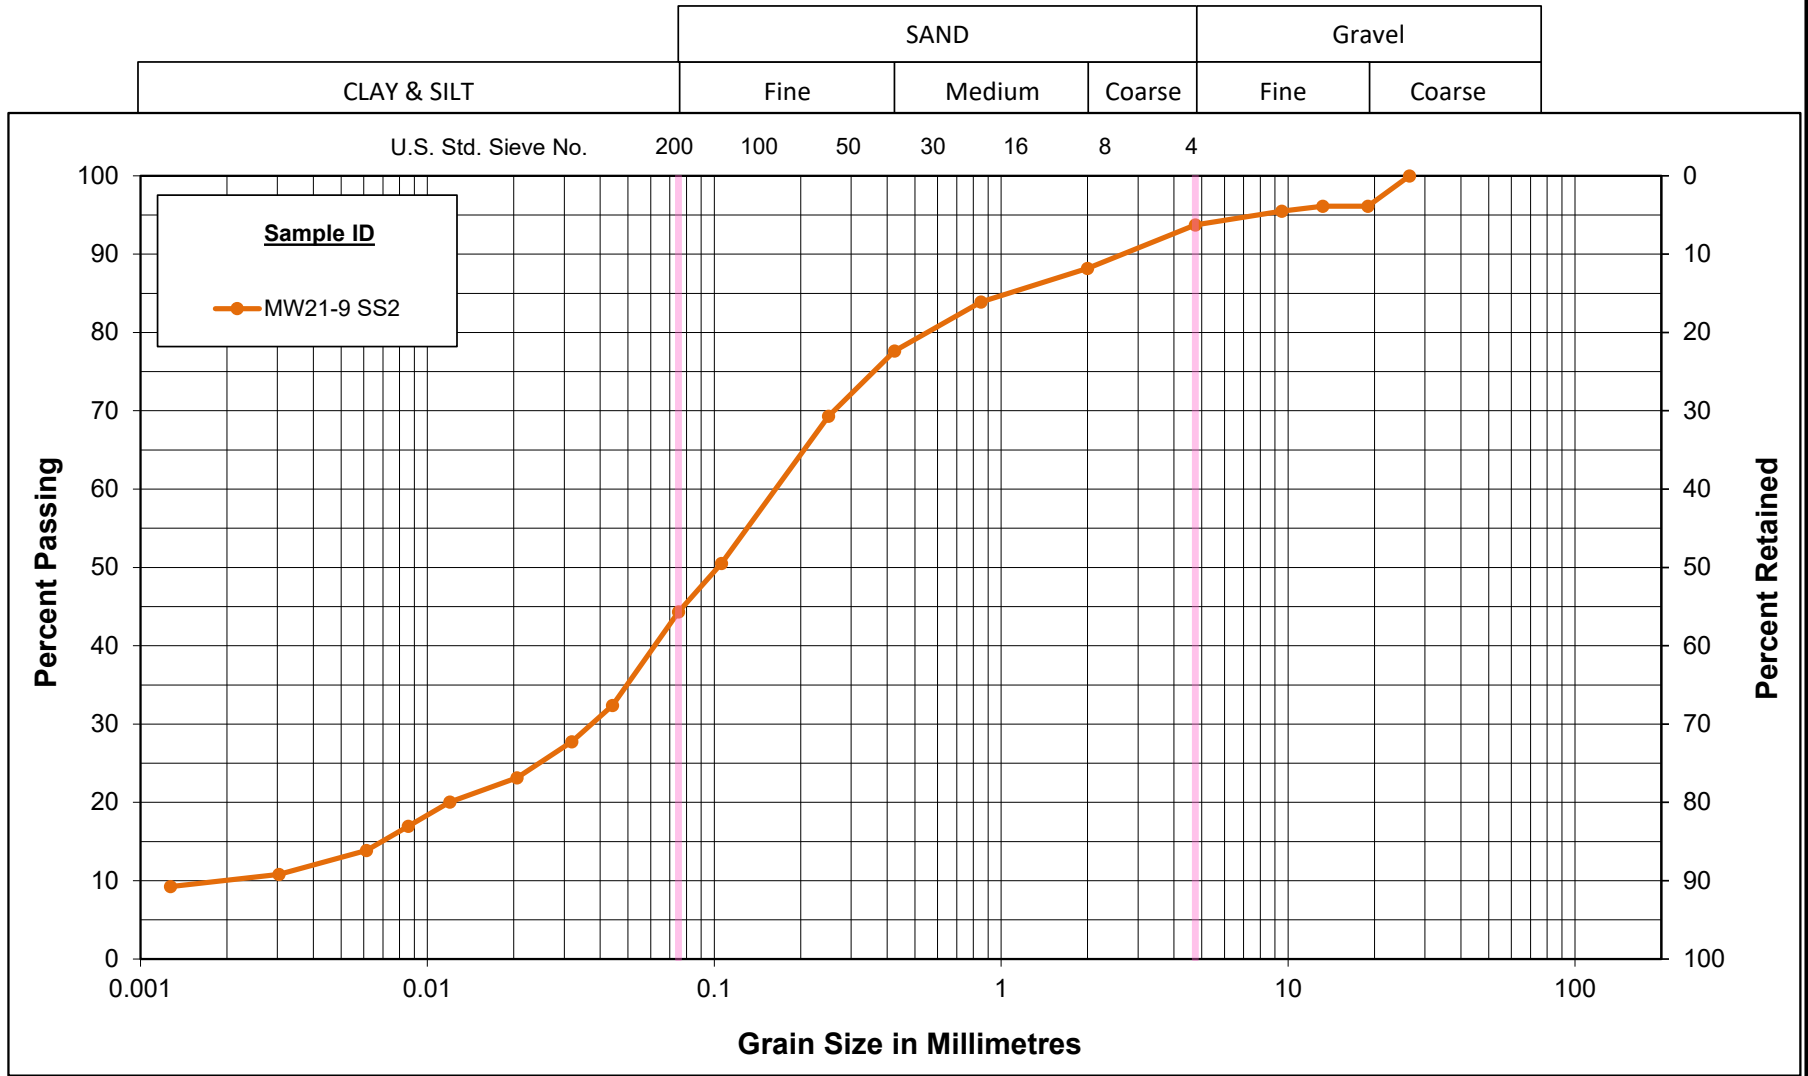
Figure No. 1

GRAIN SIZE DISTRIBUTION
FILL: Silty Sand (SM)

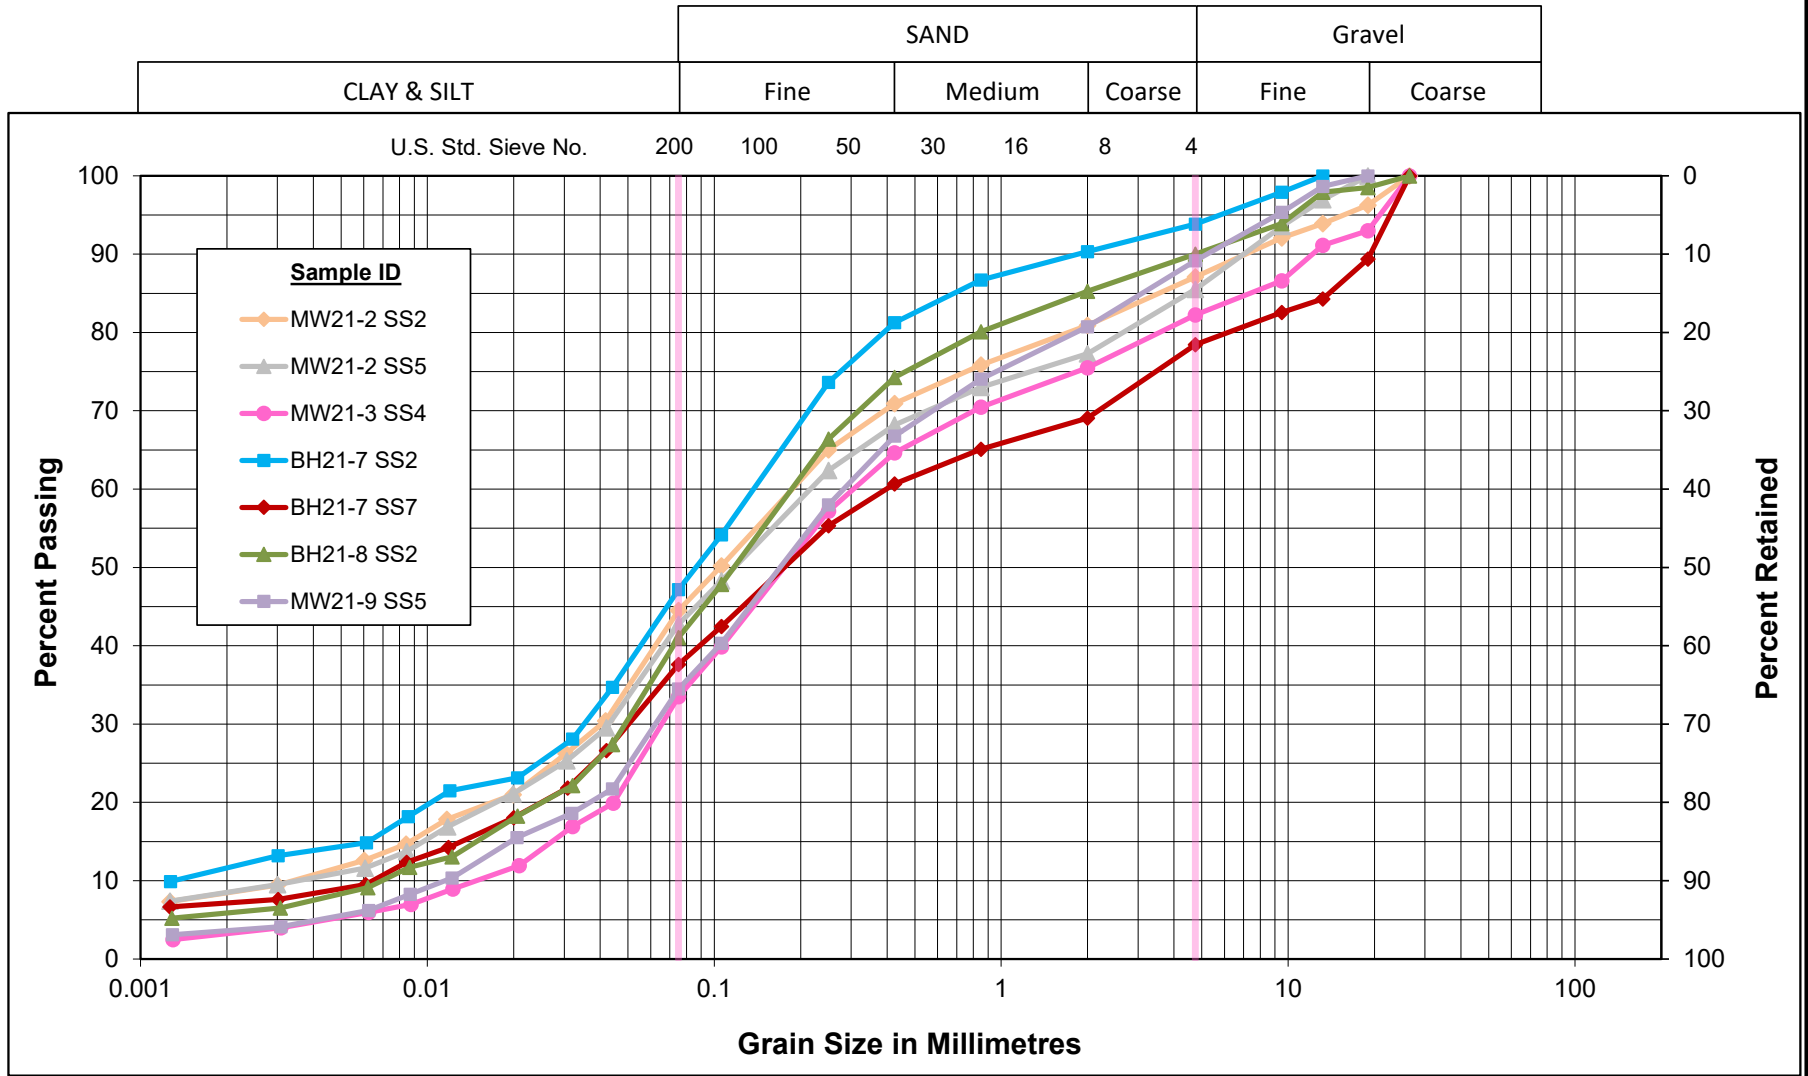
Figure No. 2

GRAIN SIZE DISTRIBUTION
Silty SAND to Silty Sand with Gravel (SM)

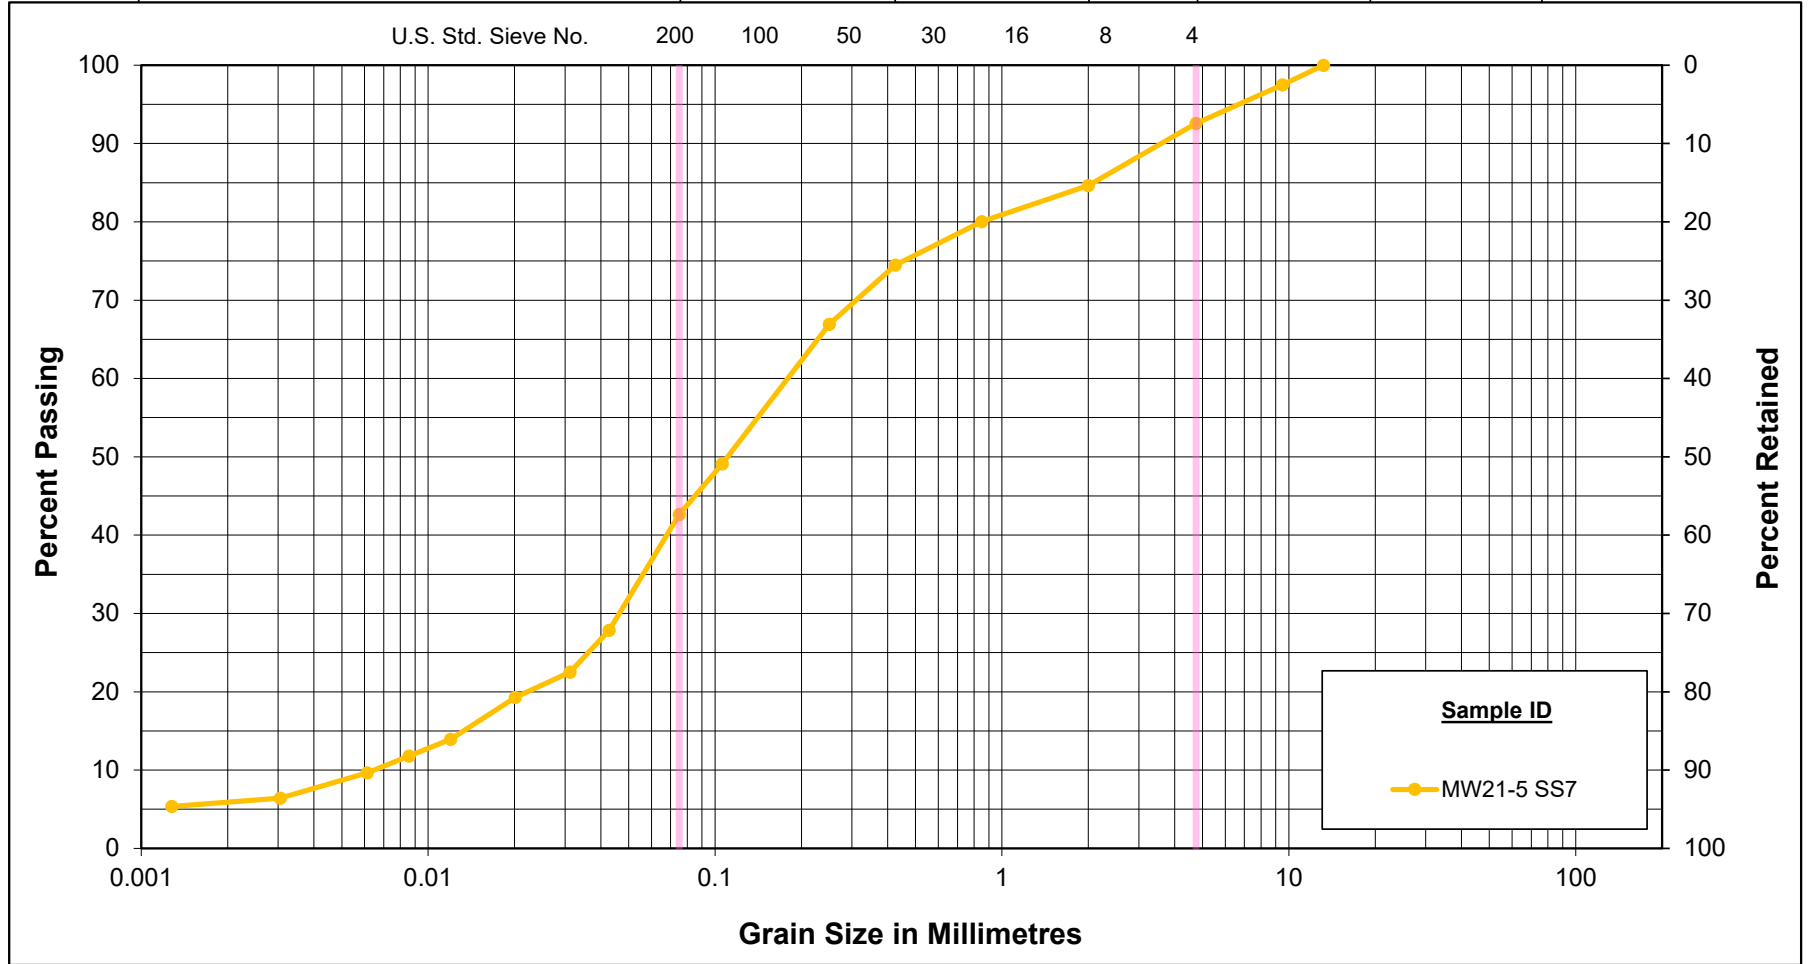
Figure No. 3

GRAIN SIZE DISTRIBUTION
Silty Sand (SM) TILL

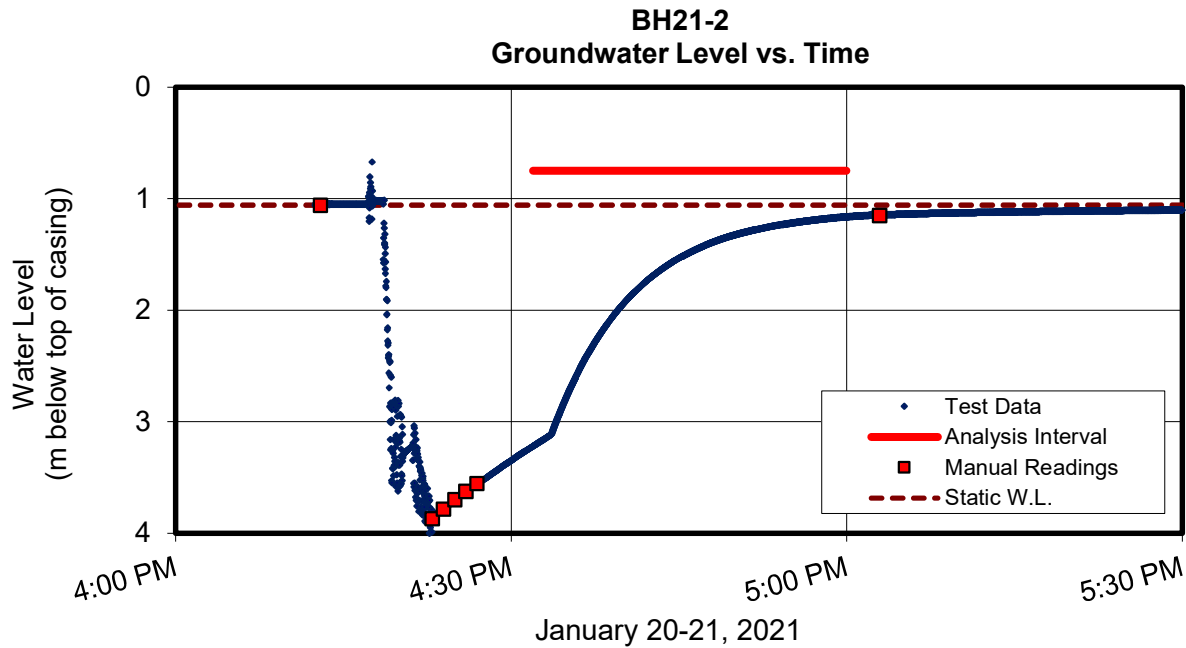
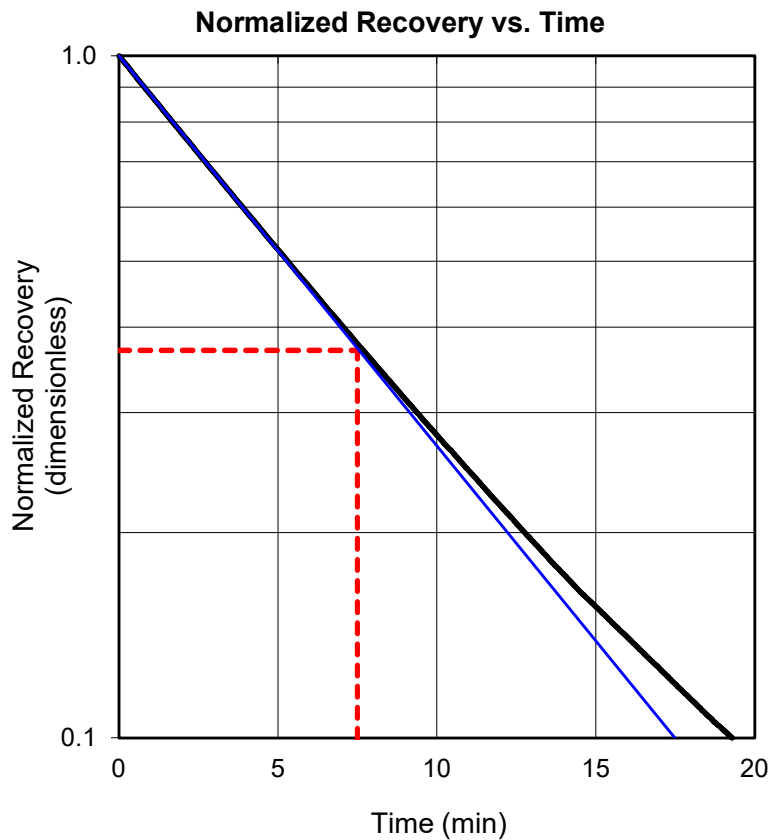
FIGURE D-1

Monitoring Well BH21-2

3.6 m - 5.4 m

Time Lag (T_0) = 7.5 min
 Sand Pack Length (L) = 1.82 m
 Well Radius (r) = 0.0254 m
 Hole Radius (R) = 0.105 m

Hvorslev Analysis

Stantec performed in-situ hydraulic response testing at all monitoring wells on January 20 and 21, 2021 to estimate the horizontal hydraulic conductivity of the overburden soil or bedrock beneath the Site. The testing consisted of creating an instantaneous change in the well water level by adding or removing a known volume of water followed by recording the time taken for the water level to return to static conditions. Data were analyzed using the Hvorslev (1951) solution. Testing provided an estimate of the horizontal hydraulic conductivity of the overburden soils or bedrock within the screened interval for each monitoring well. **Table 2** provides a summary of the calculated horizontal hydraulic conductivities, with the test results and analytical solutions presented on **Figures D-1 through D-6** in **Appendix D**.
