**Hydrogeological Report for Proposed
Wellings of Brockville Residential
Subdivision, Brockville, ON**

FINAL REPORT

November 29, 2023

Project Number:
160401602

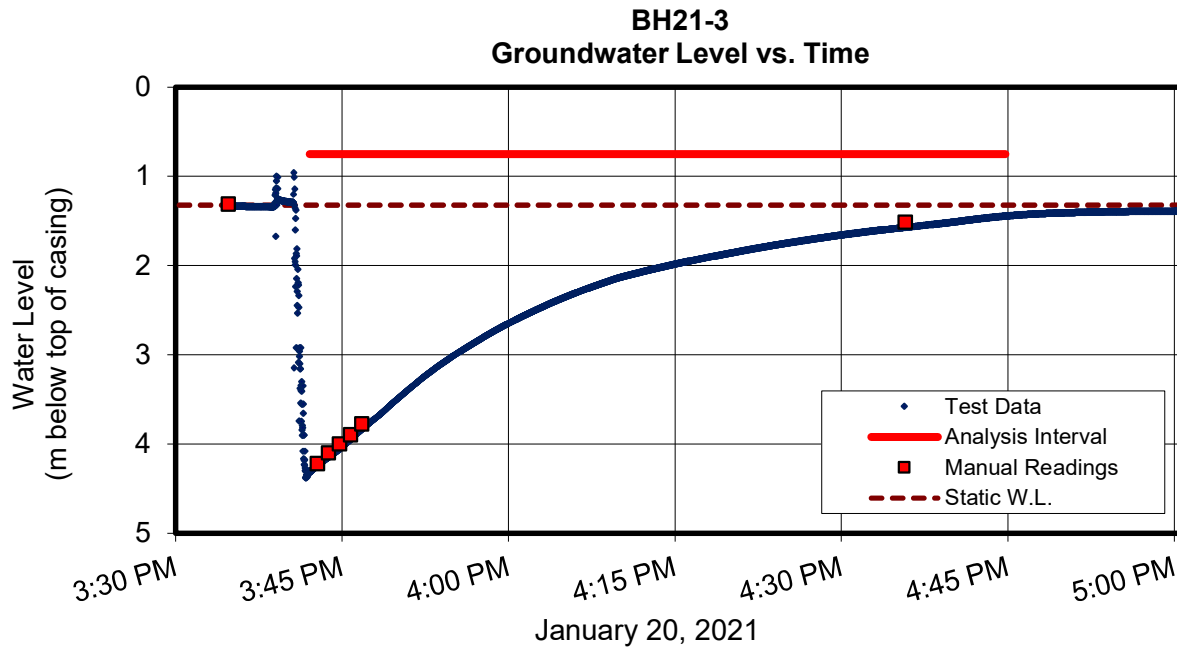
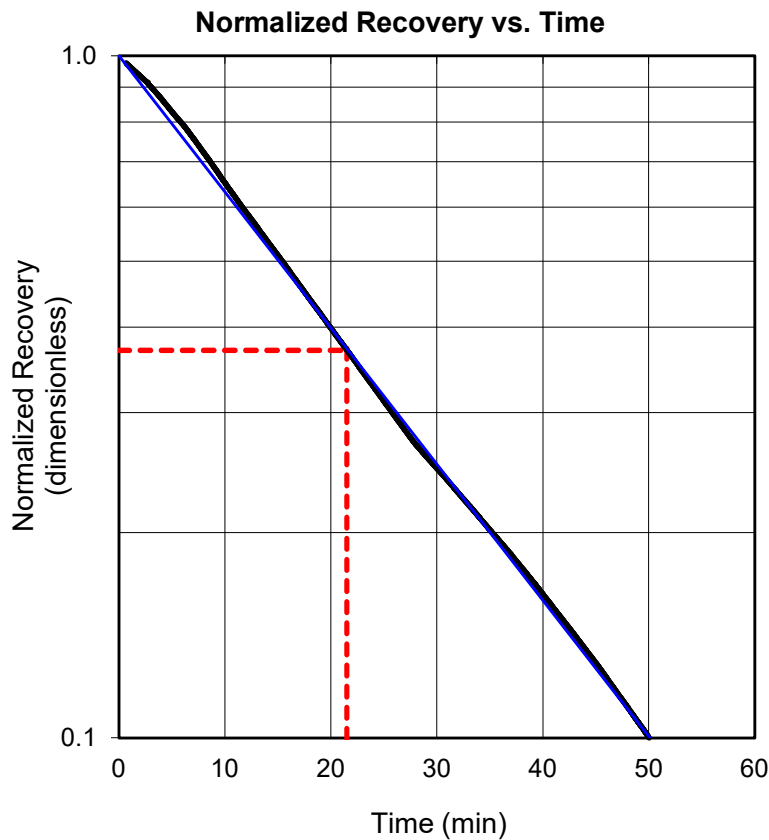
FIGURE D-2

Monitoring Well BH21-3

3.3 m - 5.1 m

Time Lag (T_0) = 21.5 min

Sand Pack Length (L) = 1.82 m

Stantec performed in-situ hydraulic response testing at all monitoring wells on January 20 and 21, 2021 to estimate the horizontal hydraulic conductivity of the overburden soil or bedrock beneath the Site. The testing consisted of creating an instantaneous change in the well water level by adding or removing a known volume of water followed by recording the time taken for the water level to return to static conditions. Data were analyzed using the Hvorslev (1951) solution. Testing provided an estimate of the horizontal hydraulic conductivity of the overburden soils or bedrock within the screened interval for each monitoring well. **Table 2** provides a summary of the calculated horizontal hydraulic conductivities, with the test results and analytical solutions presented on **Figures D-1 through D-6** in **Appendix D**.

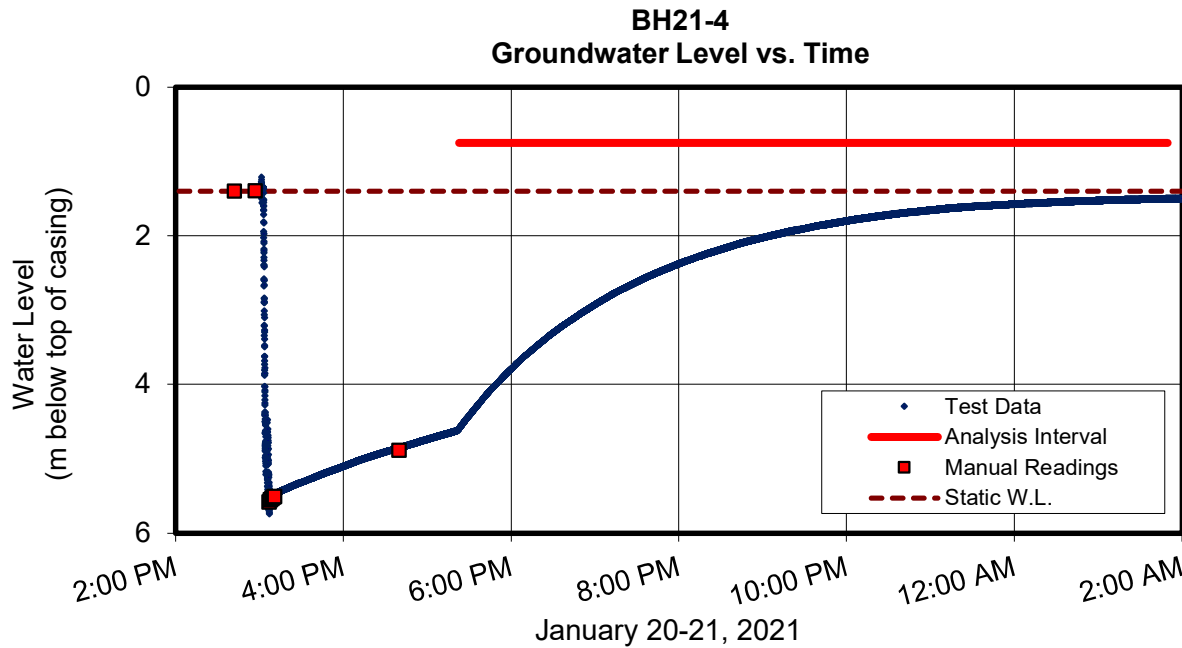
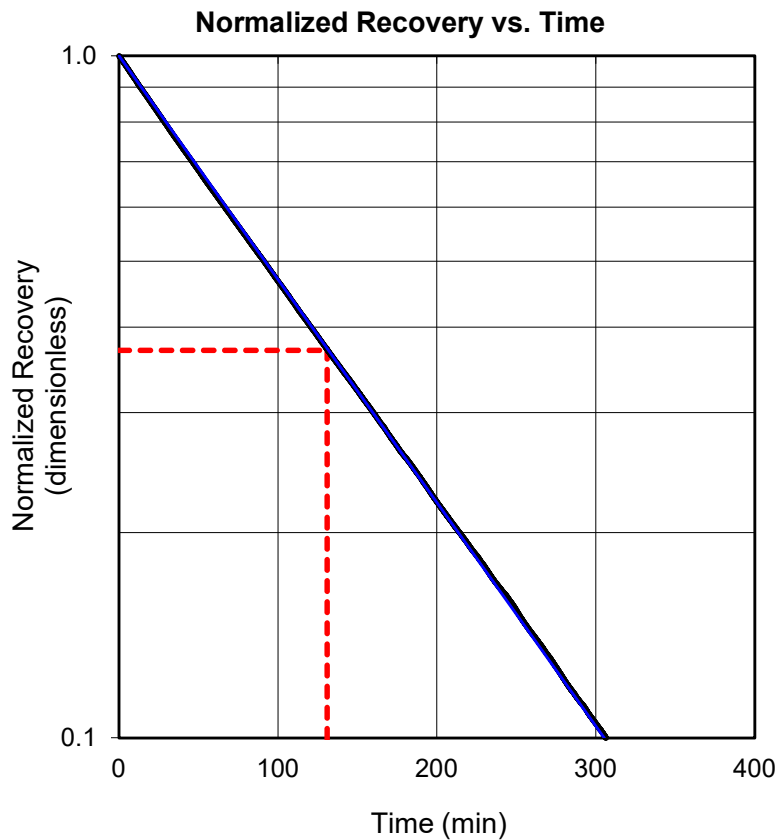
FIGURE D-3

Monitoring Well BH21-4

3.29 m - 5.11 m

Time Lag (T_0) = 131 min
 Sand Pack Length (L) = 1.82 m
 Well Radius (r) = 0.0254 m
 Hole Radius (R) = 0.105 m

Hvorslev Analysis

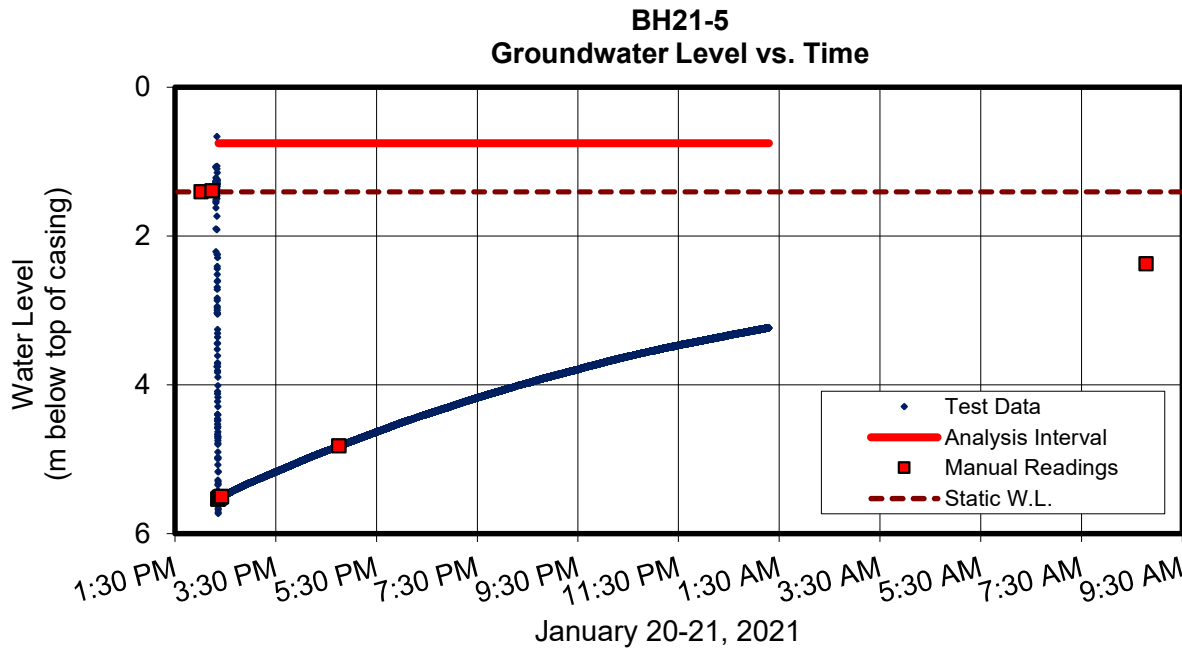
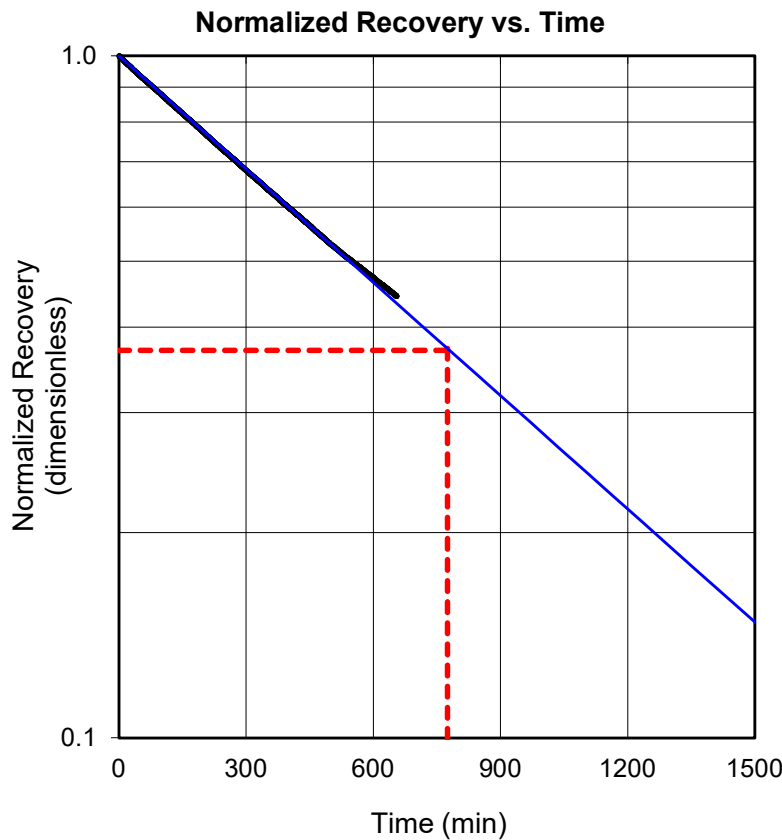
FIGURE D-4

Monitoring Well BH21-5

3.04 m - 4.87 m

Time Lag (T_0) = 775 min
 Sand Pack Length (L) = 1.83 m
 Well Radius (r) = 0.0254 m
 Hole Radius (R) = 0.105 m

Hvorslev Analysis

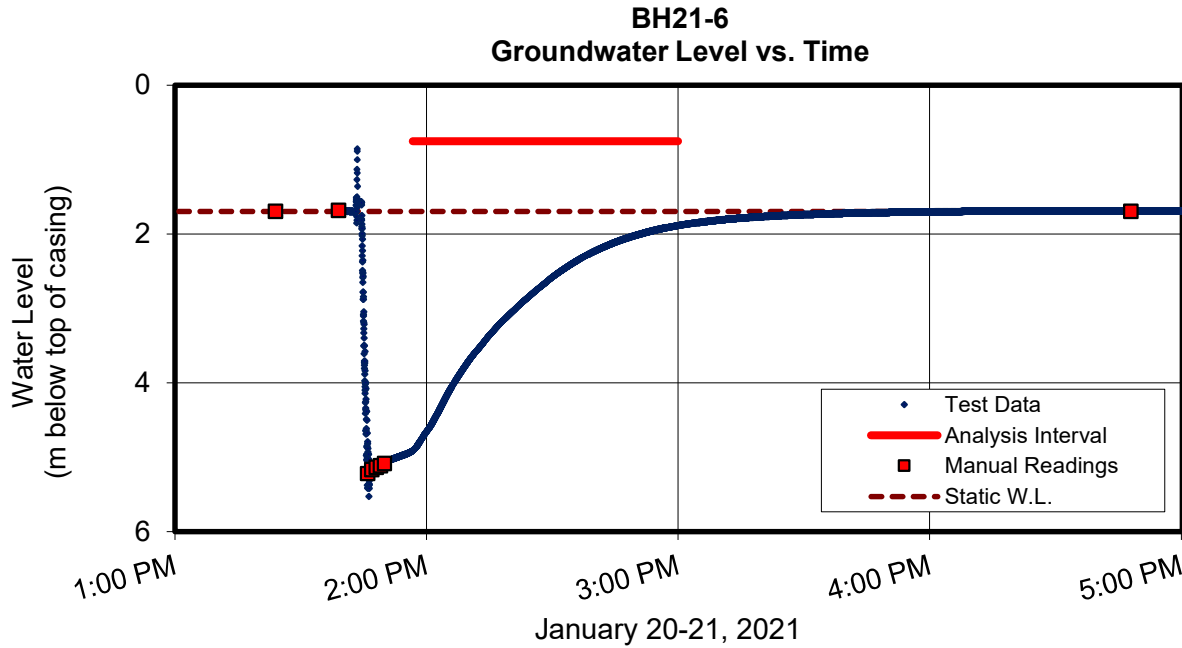
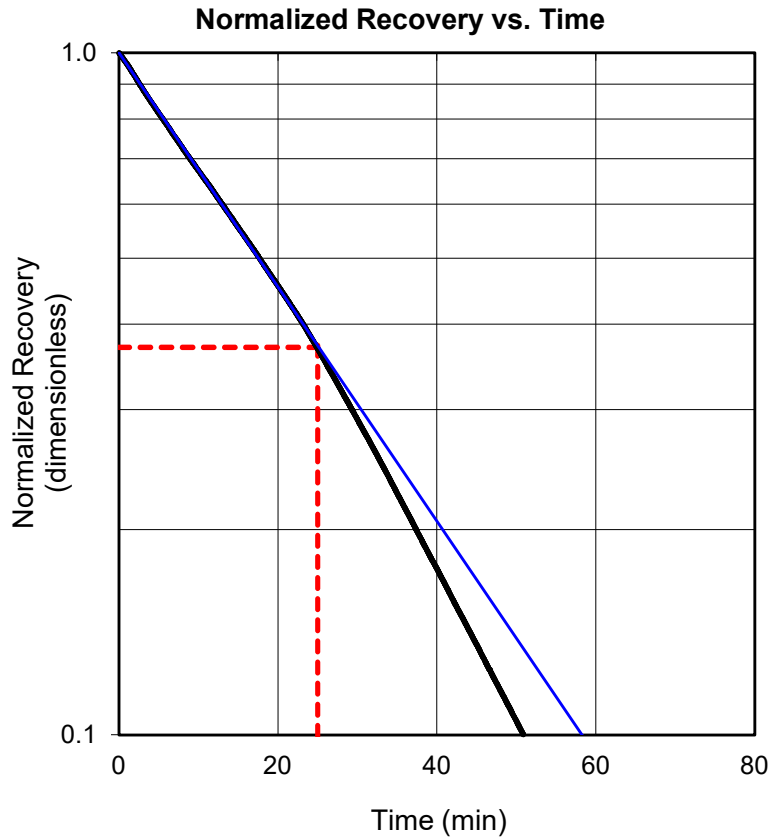
FIGURE D-5

Monitoring Well BH21-6

3.10 m - 4.93 m

Time Lag (T_0) = 25 min
 Sand Pack Length (L) = 1.83 m
 Well Radius (r) = 0.0254 m
 Hole Radius (R) = 0.105 m

Hvorslev Analysis

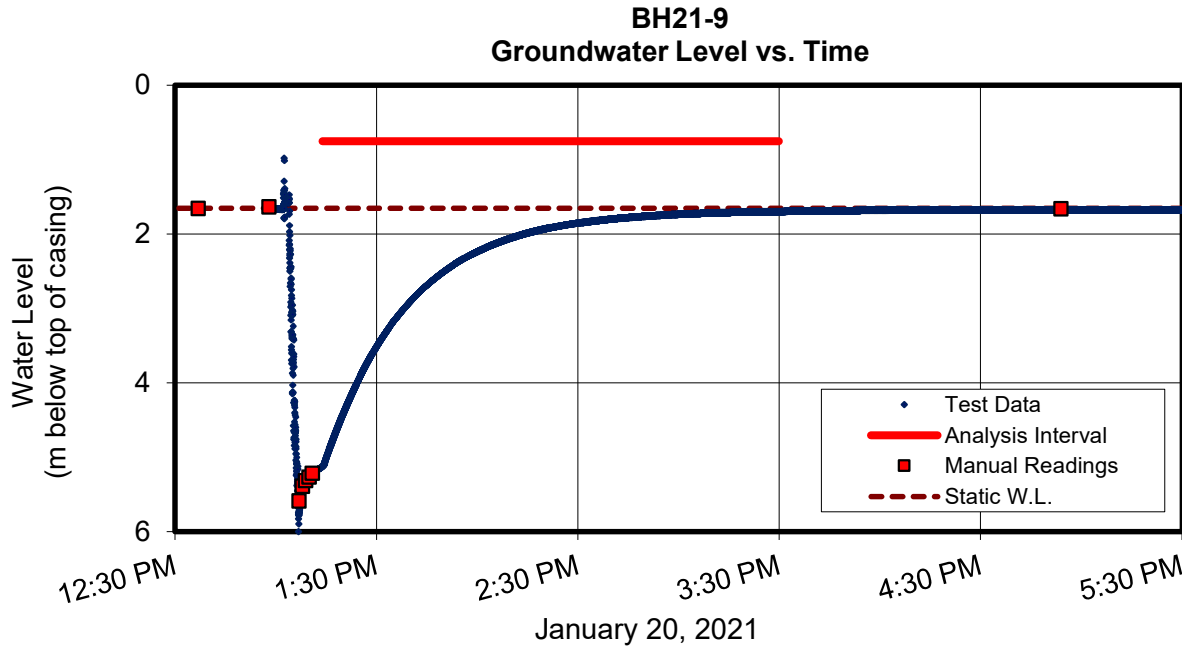
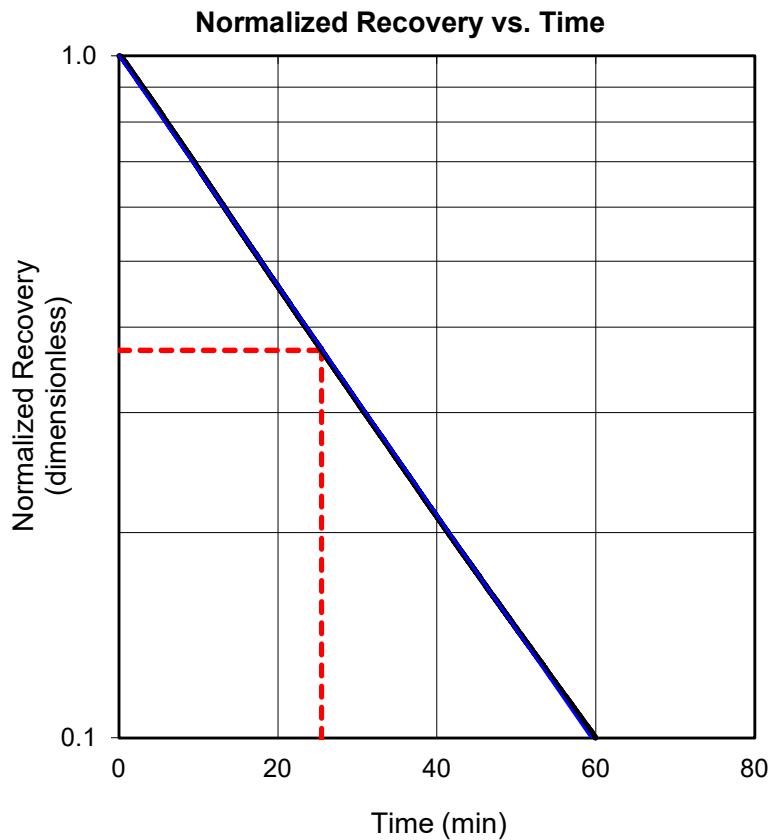
FIGURE D-6

Monitoring Well BH21-9

3.26 m - 5.09 m

Time Lag (T_0) = 25.5 min
 Sand Pack Length (L) = 1.83 m
 Well Radius (r) = 0.0254 m
 Hole Radius (R) = 0.105 m

Hvorslev Analysis
